**Sequim Museum  
Schematic Design Report**

# ***Schematic Design***

Washington Harbor Schoolhouse

Schematic Design  
**Museum & Arts Center**  
**Captain Morris House /**  
**Washington Harbor Schoolhouse**  
 Sequim, Washington

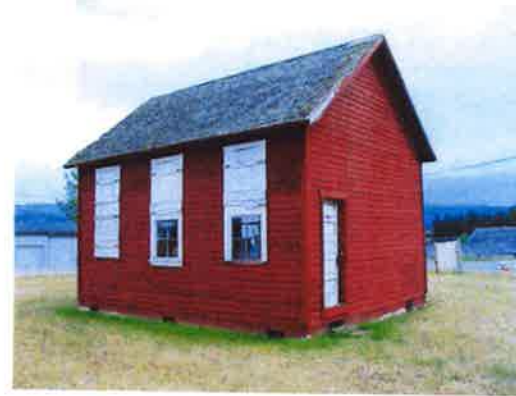
The exterior and interior of the Schoolhouse has retained its historic integrity. Most noticeable exceptions are the shorter replacement windows and shutters. Less obvious is the missing chimney through the roof.

Some of the wainscot is missing and all of the plaster walls and ceiling is gone but they can be repaired and replaced to make the interior look very close to the way it was originally.

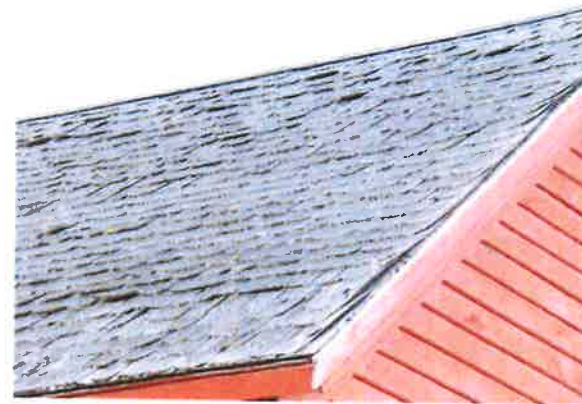
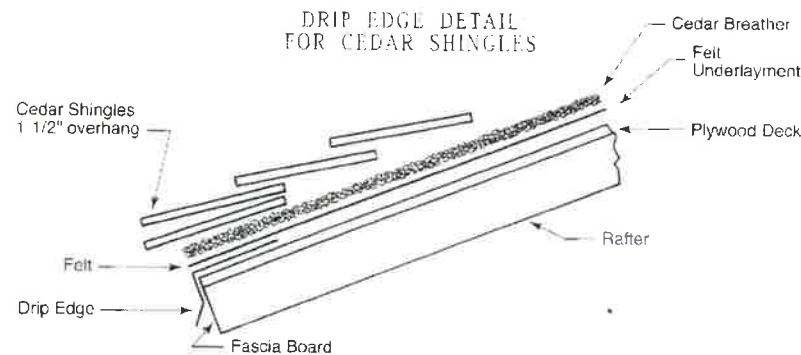
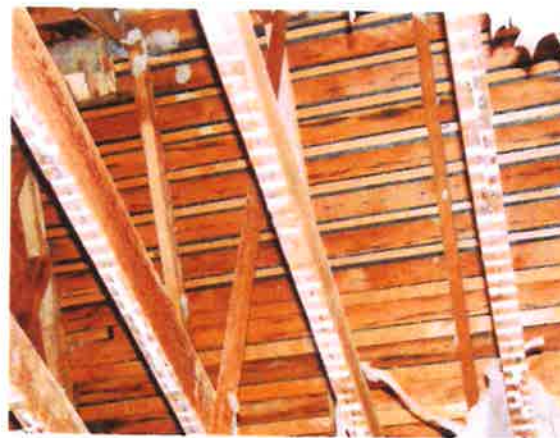
Recommendations  
Roof Covering

The wood shingles are far past their life cycle and need to be replaced. Indeed, it is hard to believe that the roof does not leak.

An option would be to lay composition shingles that match those on the Captain Morris House but then both structures would NOT be providing an historic image. Wood shingles best represent the historic character and period.

Plywood will stiffen the roof structure; Cedar Breather will greatly extend the life of the wood shingles. Chemco Shingles can provide a higher level of fire retardancy and can meet the highest building code requirements.

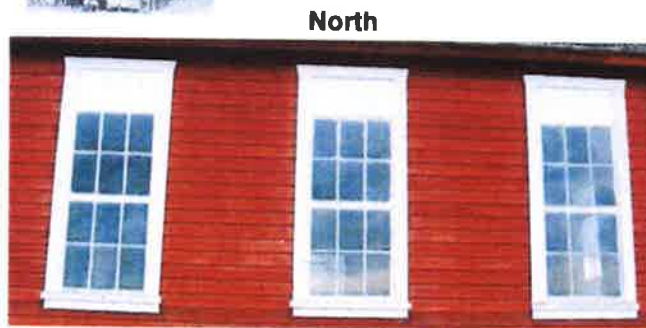
Details from early photo. Note they have an 33-3/4" x 84" opening and are 2/2, double hung

fabricate and replace sash, remove shutters, make repairs to trim and sills

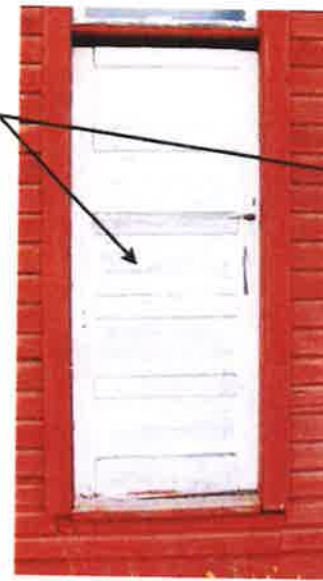
West (front)

Both doors need repair and hardware.

- Remove doors and remove lead paint (strip according to safe practice and disposal - see reference EPA site)
- Make repairs to door, sills, and trim
- Install period hardware; make doors operate

repair sill to transition with walking deck

repair and repaint;  
install period hardware

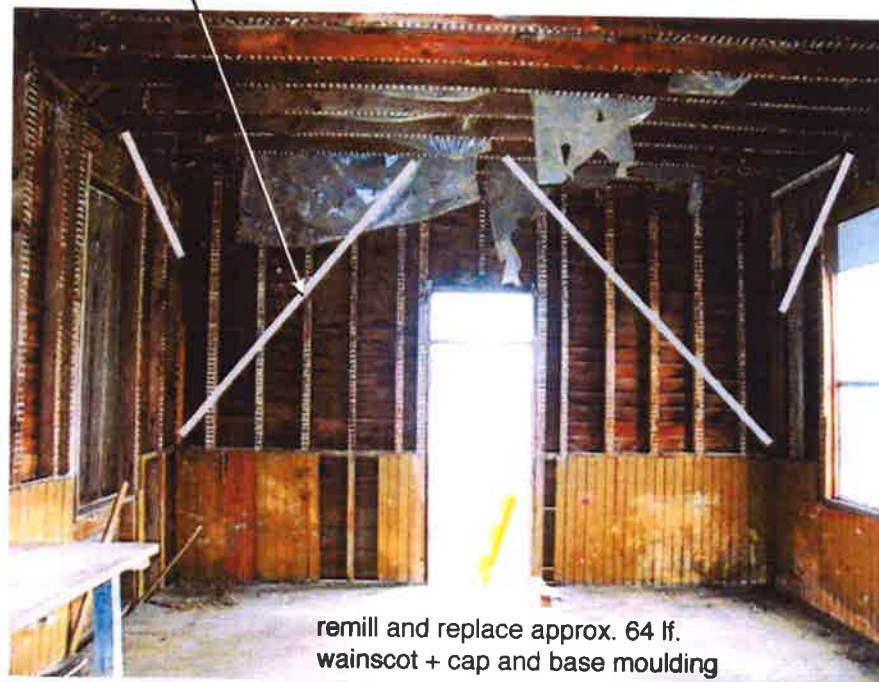
Repair of wainscot and walls to their historic appearance.

Drywall is a more practical and acceptable substitute for the original plaster walls.

install (optional) strap ties at corners - let into studs

remill and replace approx. 64 lf.  
wainscot + cap and base moulding

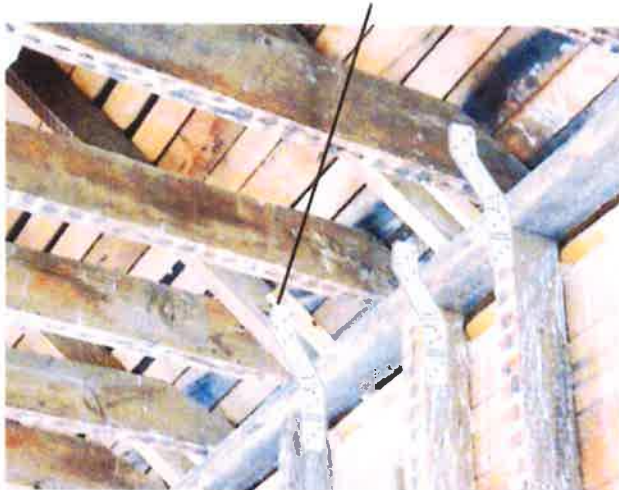
diagonal wire rope bracing make-up

- Fasten plank across tops of joists; replace wood bracing with wire rope; erect end bracing to ridge
- Install R-19 fiberglass insulation between joists
- Install 6 mil vapor barrier over inside face of joists
- Lay and finish drywall over to create ceiling

install hurricane ties at each rafter

Simpson Seismic Tie H2.5T or equivalent

replace 1 x 4 wood bracing with wire rope; use eye, thimble, clips, and turnbuckle

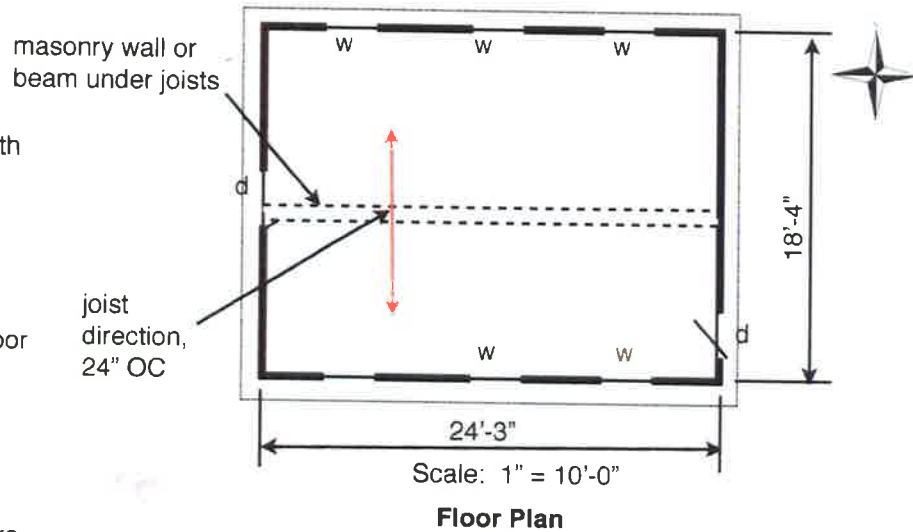
Resupporting the floor provides additional safety for future and unknown live loads. Treat of all wood now and periodically will control insects and fungal growth.

- Foundation not part of this schematic design
- Install seismic straps from foundation to studs
- Multiple saturations of wood preservative to entire floor structure
- Sister joists
- Sand and finish flooring

Treat all wood with  
BoraCare preservative  
<http://www.nisuscorp.com>

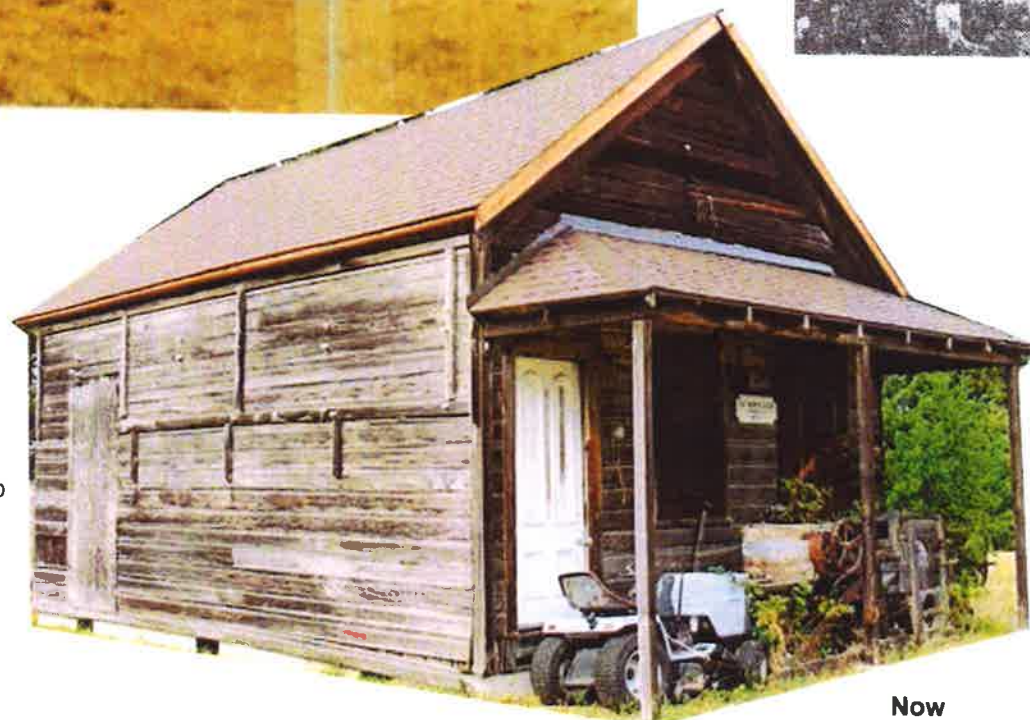
Now

Information about the early appearance of the house is scant other than from these photographs. The main differences in these images are the removal of the garage / shop shed, the porch surround, and chimney. The window casing at the rear is not of the same period of the others but it could have been a replacement. No photos were found of the interior.

- Options -
  - retain the current composition shingles for now and revert to wood shingles at the next roof covering change.
  - replace the current roof covering with wood shingles.

Wood shingles best represent the historic character and period of the building.

Use of Ice and Water Shield will provide a high level of leak protection for the roof. Cedar Breather will greatly extend the life of the wood shingles. Chemco Shingles can provide a higher level of fire retardancy and can meet the highest building code requirements.

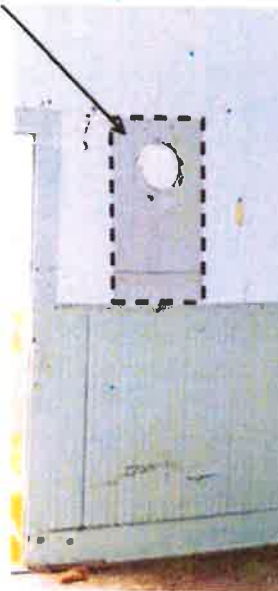
Interior

The exterior shelf chimney at the rear has been removed. The upper portion of the interior chimney has been removed while the lower portion extending into the front parlor is corroded.

Additional structural support is needed for exterior chimney. Make chimneys look as they did at the period of interpretation but not to be functional.

- Reinforce the rear chimney shelf. See details
- Reconstruct a NON FUNCTIONAL chimney with exposed brick using light weight bricks - Z-Brick or equal. [www.z-brick.com](http://www.z-brick.com) Used brick appearance and a lightweight mortar should be used. Cap at the top. Match appearance, sizing, height as shown in the historic photo. Flash by conventional methods with black flashing.
- Clean and make repairs to visual portion of parlor chimney. Do not install flue pipe through roof.

1/4" steel plate to interior wall bolted to exterior internal straps

Both chimneys to be NON FUNCTIONAL

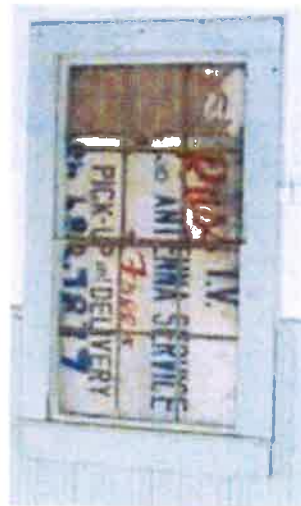
Interior

Front and rear doors need repair and hardware. It is assumed that the north door will require the same. (was boarded over) Trace of lead was found in the paint on the doors, trim, and jambs. (based on LeadCheck© swab test)

- Remove existing sash; remove glass; **PROTECT GLASS**, strip paint (contains lead), make repairs. reglaze, refinish interior. Attempt to preserve details of sash corners and muntins. Do not replace sash.
- 2 options - either encapsulate the lead paint on the trim, sills, and casing **OR** replace the wood that has lead paint on it.

Reuse old glass.  
Do not break !

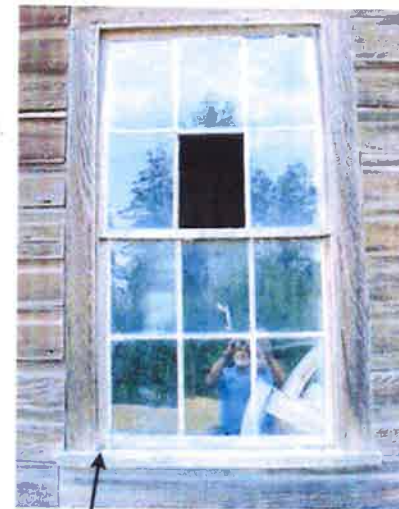
Exterior

Paint contains lead.

- Remove doors and remove lead paint (strip according to safe practice and disposal - see reference EPA site)
- Make repairs to door, sills, and trim
- 2 options - either encapsulate the lead **OR** replace the trim that has lead paint on it.
- Install period hardware; make doors operate properly

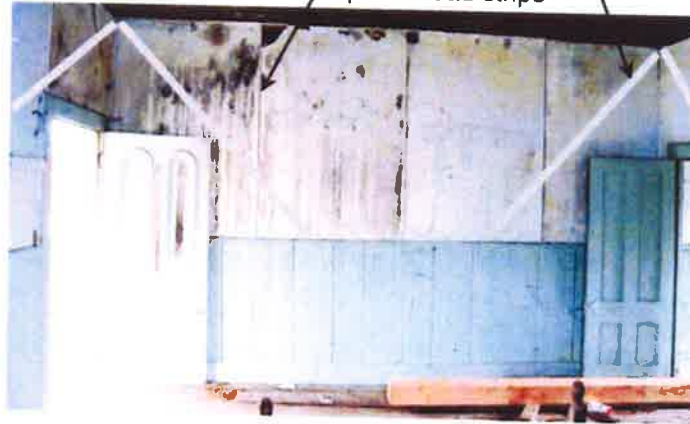
Repair of wainscot and walls to their historic appearance.

- Remove and discard upper pressed board. May include Simson MST strap ties over studs in corners. [http://www.strongtie.com/products/categories/straps\\_w.html](http://www.strongtie.com/products/categories/straps_w.html). Replace board with 3/8" dry wall. Apply bead strips at 4' intervals to match existing.
- Retain wainscot and keep in place. Either strip paint (contains lead) and repaint or encapsulate). Repair or replace wainscot cap. Replace baseboard.
- Finish.

install (optional) strap ties at corners - let into studs

replace bead strips

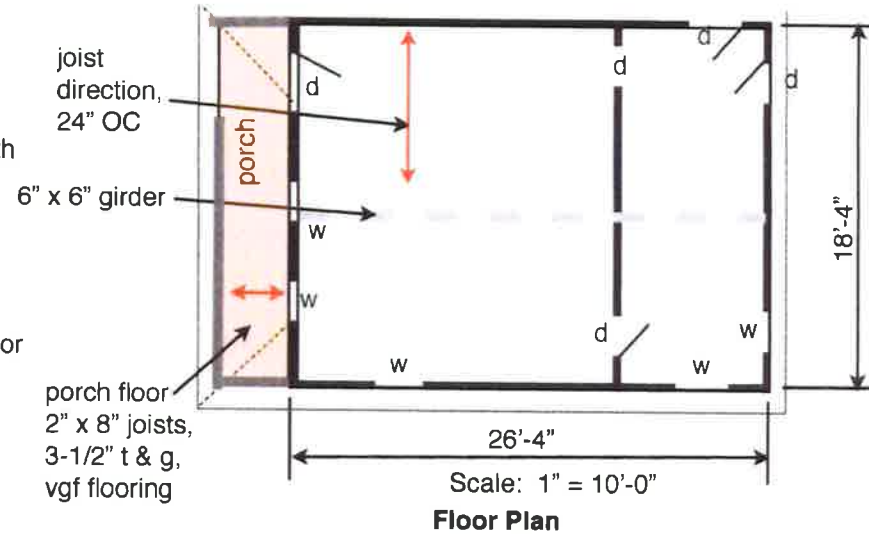
Resupporting the floor provides additional safety for future and unknown live loads. Treatment of all wood now and periodically will control insects and fungal growth.

- Foundation not part of this schematic design
- Install seismic straps from foundation to studs
- Multiple saturations of wood preservative to entire floor structure
- Sister joists
- Repair sub-floor and replace finish flooring; finish

Treat all wood under building with BoraCare

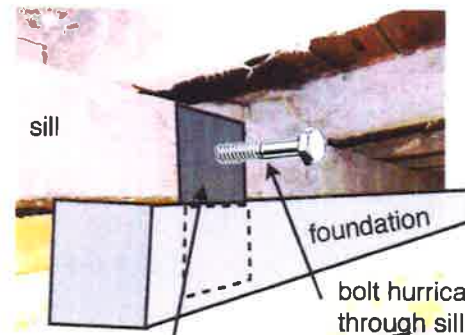
6" x 6" girder

2" x 6" joists approx. 24" OC

bolt hurricane strap through sill and vertical sheathing; hide head behind siding

replace deteriorated sub flooring; replace finished flooring (t & g, vertical grain fir); finish
